**Flood Control Project Maintenance
Levee Inspections****LMA District Cover Sheet****Spring 2011 Levee Inspection Results****Sutter Maintenance Yard East Levee Sacramento River**

Spring 2011 Levee Inspection Results

Sutter Maintenance Yard East Levee Sacramento River

Levee Inspection Report By Mile - Spring 2011

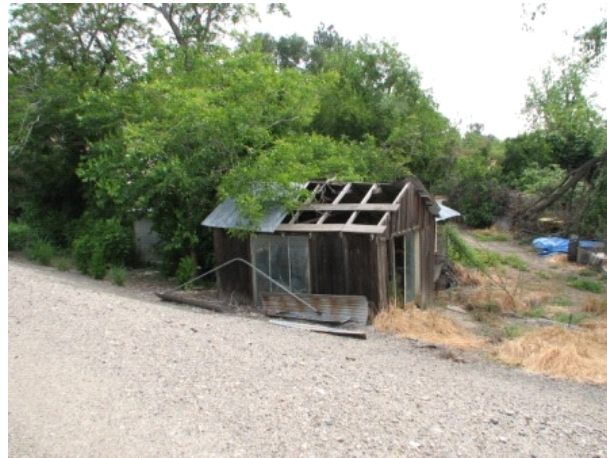
Levee Mile Report Line	1
Start Levee Mile	0.08
End Levee Mile	0.14
Location	Water Side
Category	Earthen Levee
Item	Encroachments

View of a old building next to the landside toe.

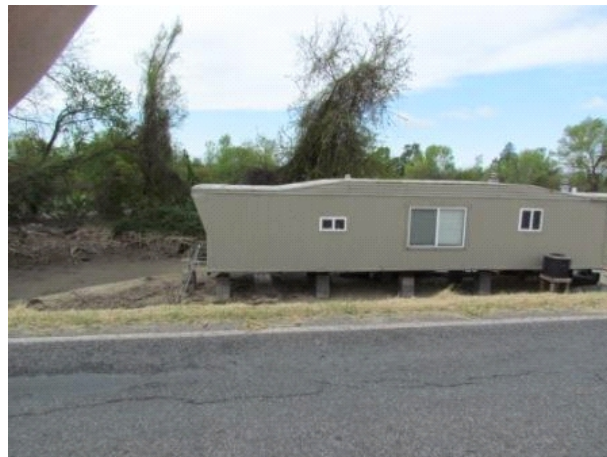
Levee Mile Report Line	2
Start Levee Mile	4.19
End Levee Mile	4.19
Location	Water Side
Category	Earthen Levee
Item	Encroachments

View of the trailer next to the W/S toe.

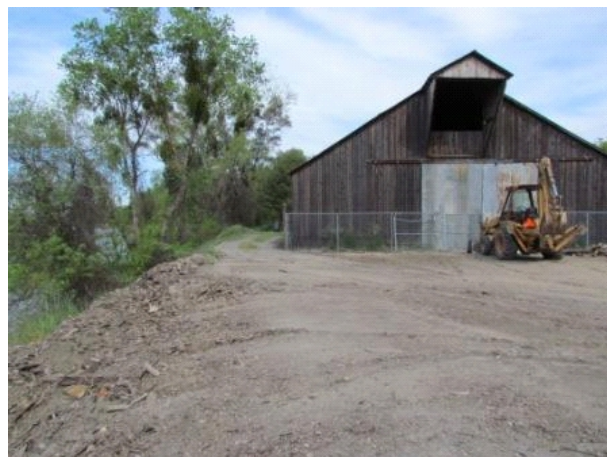
Levee Mile Report Line	3
Start Levee Mile	4.66
End Levee Mile	4.84
Location	Crown
Category	Earthen Levee
Item	Encroachments

View of the barn on the large crown of the levee.

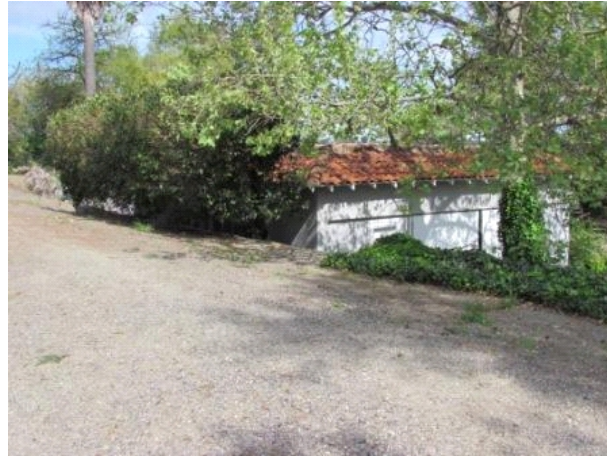
Levee Mile Report Line	6
Start Levee Mile	4.81
End Levee Mile	4.81
Location	Land Side
Category	Earthen Levee
Item	Encroachments
View of the building next to the L/S toe.	
rduffey_s_20110419_243.jpg

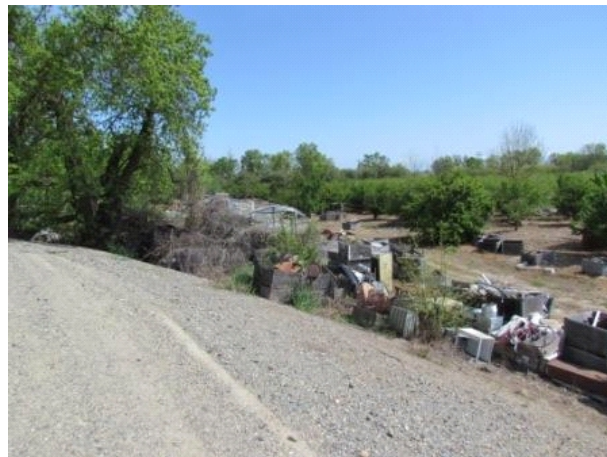
Levee Mile Report Line	11
Start Levee Mile	6.42
End Levee Mile	6.42
Location	Land Side
Category	Earthen Levee
Item	Encroachments
View of the material & garbage along the toe.	
rduffey_s_20110419_244.jpg

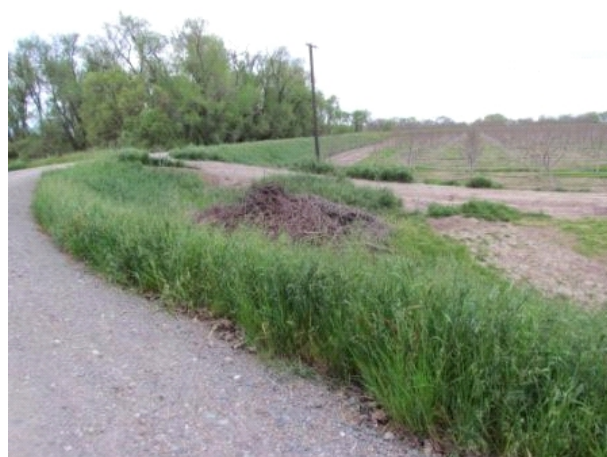
Levee Mile Report Line	13
Start Levee Mile	9.23
End Levee Mile	9.23
Location	Land Side
Category	Earthen Levee
Item	Encroachments
View of the prunings along the L/S toe.	
rduffey_s_20110419_246.jpg

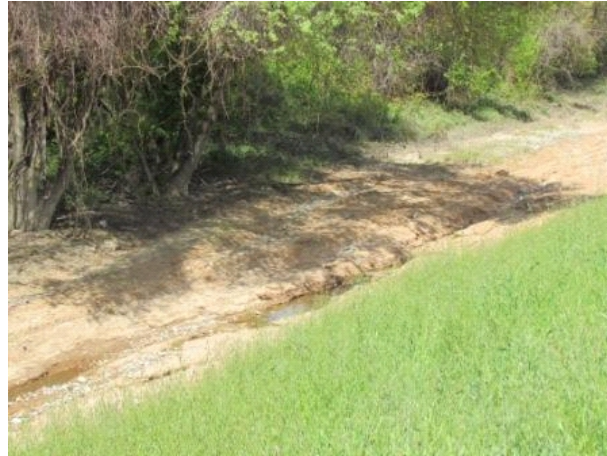
Levee Mile Report Line	19
Start Levee Mile	13.47
End Levee Mile	13.66
Location	Water Side
Category	Earthen Levee
Item	Erosion / Bank Caving

View of the erosion along the W/S toe.

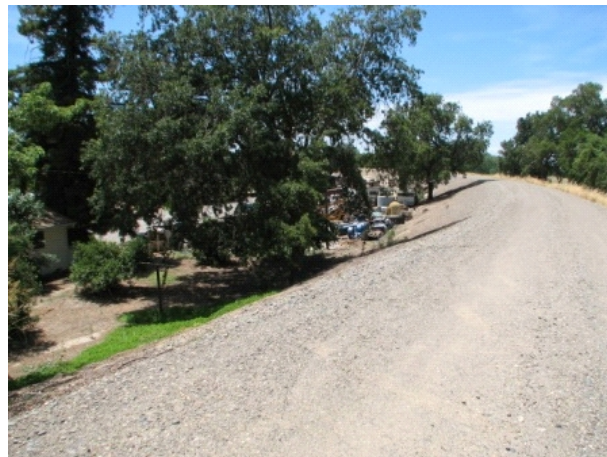
Levee Mile Report Line	22
Start Levee Mile	18.04
End Levee Mile	18.18
Location	Land Side
Category	Earthen Levee
Item	Encroachments

View of the equipment and trees next to the landside toe of the levee.

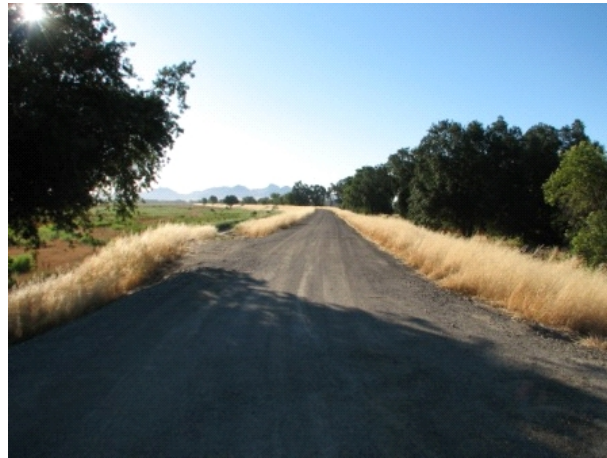
Levee Mile Report Line	1
Start Levee Mile	0.01
End Levee Mile	0.01
Location	Land Side
Category	Earthen Levee
Item	Vegetation

View of the elderberries along the landside toe of the levee.

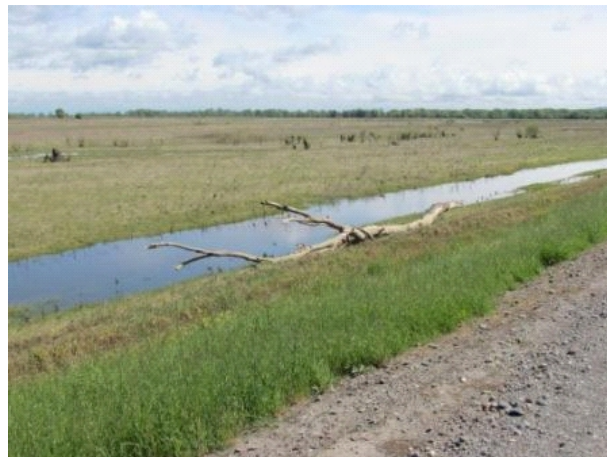
Levee Mile Report Line	3
Start Levee Mile	0.74
End Levee Mile	0.74
Location	Water Side
Category	Earthen Levee
Item	Encroachments

View of debris along the W/S toe.

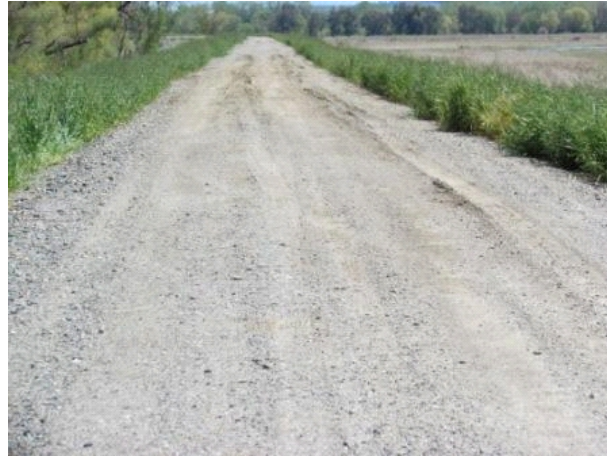
Levee Mile Report Line	1
Start Levee Mile	0.58
End Levee Mile	0.94
Location	Crown
Category	Earthen Levee
Item	Crown Surface / Depressions / Rutting
View of the crown roadway needing gravel & grading.	
rduffey_s_20110419_249.jpg

LMIR No.	Levee Mile		Category	Item	* Location	** Rating	Action/Comment	GPS Latitude/Longitude		Issue No.
	Start	End						Start	End	Photo
1	0.58	0.94	Earthen Levee	Crown Surface / Depressions / Rutting	CR	M	Add appropriate gravel or road base. Grade and compact.	39.237300 ° -121.983615 °	39.238705 ° -121.977045 °	1 Y
2	1.98	1.98	Earthen Levee	Vegetation	LS	M	Elderberries are blocking visibility and flood fight capability.	39.244888 ° -121.965595 °	39.244888 ° -121.965595 °	10 Y
3	2.17	2.17	Earthen Levee	Vegetation	WS	M	Elderberries are blocking visibility and flood fight capability.	39.244838 ° -121.962072 °	39.244838 ° -121.962072 °	13

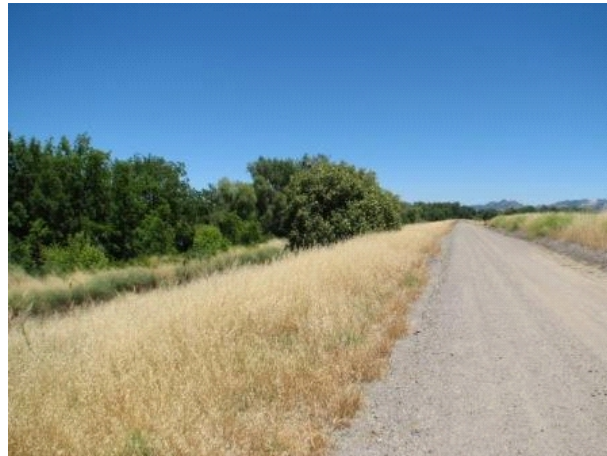
Levee Mile Report Line	2
Start Levee Mile	1.98
End Levee Mile	1.98
Location	Land Side
Category	Earthen Levee
Item	Vegetation
View of the elderberries along the landside toe of the levee.	
rduffey_s_20110228_215.jpg

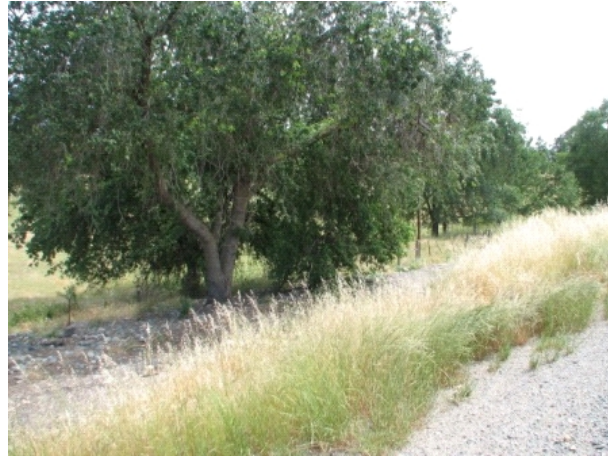
Levee Mile Report Line	1
Start Levee Mile	0.02
End Levee Mile	0.02
Location	Water Side
Category	Earthen Levee
Item	Vegetation

View of a Elderberries bush by the waterside toe.

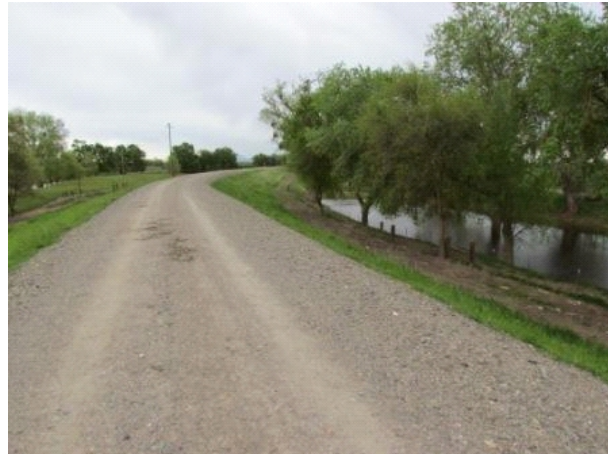
Levee Mile Report Line	3
Start Levee Mile	0.07
End Levee Mile	0.07
Location	Land Side
Category	Earthen Levee
Item	Vegetation

View of the clean levee.

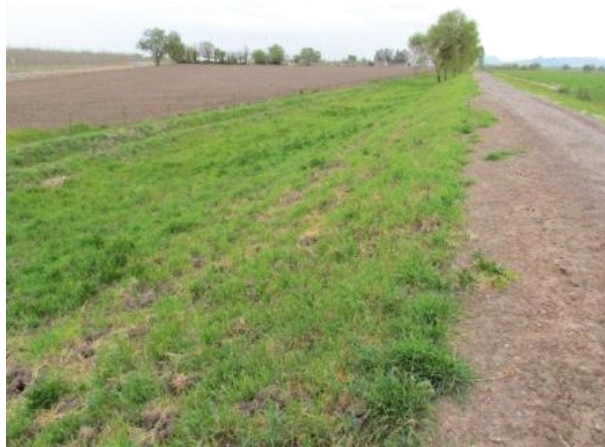
Levee Mile Report Line	1
Start Levee Mile	0.79
End Levee Mile	1.58
Location	Land Side
Category	Earthen Levee
Item	Animal Control

View of the levee slopes damaged by livestock.

LMR No.	Levee Mile		Category	Item	* Location	** Rating	Action/Comment	GPS Latitude/Longitude		Issue No. Photo
	Start	End						Start	End	
1	0.79	1.58	Earthen Levee	Animal Control	LS	M	Repair the levee slope damaged by livestock and prevent large animal access.	39.340568 ° -122.009183 °	39.335837 ° -121.995885 °	1 Y
2	0.94	0.94	Earthen Levee	Animal Control	LS	C	No rodents visible, but rodent burrows visible; need to backfill and compact or grout burrows.	39.339592 ° -122.006717 °	39.339592 ° -122.006717 °	4
3	1.08	1.08	Earthen Levee	Animal Control	LS	M	No rodents visible, but rodent burrows visible; need to backfill and compact or grout burrows.	39.338605 ° -122.004365 °	39.338605 ° -122.004365 °	2
